# National report of Saint Vincent and Grenadines: fish aggregating device development in Saint Vincent and the Grenadines

# National report of Trinidad and Tobago: Summary on site selection, design and mooring of fish aggregating devices

# National report of Aruba, Curaçao, Bonaire 1993–2004

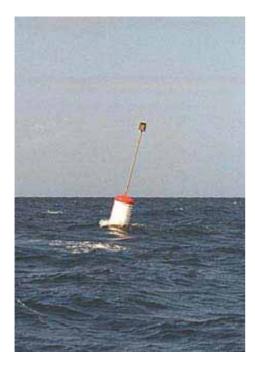
MKII FAD-GRP3, 700 m mooring depth

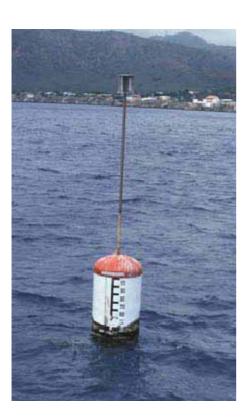
MKII-GRP8 Weak current 430 m mooring depth Considerable reserve buoyancy remaining

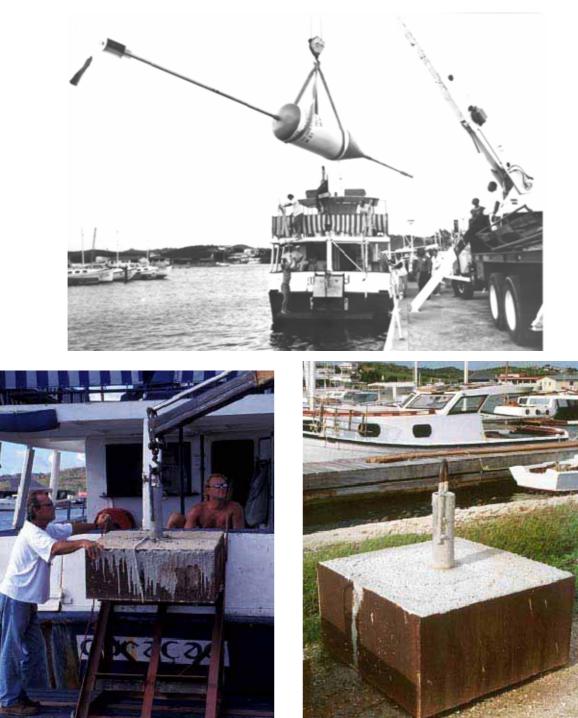
Old type anchor (1 260 kg) Being lowered on ramp

**1 500 kg anchor** The weight of the anchor has been increased from 1 260 kg to approx. 1 500 kg The underwater weight of the anchor is approx. 1 000 kg

- The weight of the anchors has now been increased from 1 200 to 1 500 kg. The MKII buoys will not be moored deeper than 600 m, to avoid them being pulled under by the currents, which can be very strong occasionally. This is based on calculations done by Mr Alain Lebeau, IFREMER, assuming a maximum surface current strength of 2.7 knots, which is reduced to 1/3 of its strength at 150 m depth and from there linearly reduced to zero at the bottom. South of Seru, Colorado in Aruba, the currents can be even stronger and may well reach 3 knots or more. Furthermore it seems likely that these currents run all the way to the bottom, without diminishing much in strength (it is reported that this has been observed in a small submarine diving to the bottom at 180 m). As a result even though the mooring depth of FADs around Aruba is much less, plenty of reserve buoyancy and a heavy anchor (1 200–1 500 kg) are still needed. In Aruba a somewhat

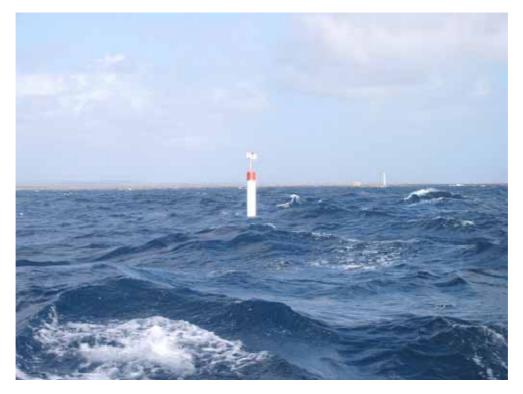
FAD RVS3 at Spelonk, Bonaire, 440 m mooring depth

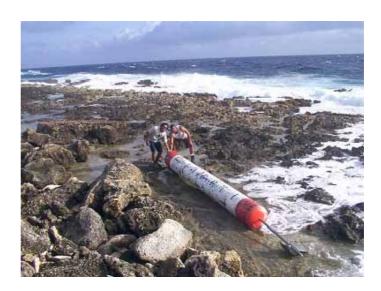
4 days later, Sic transit gloria mundi

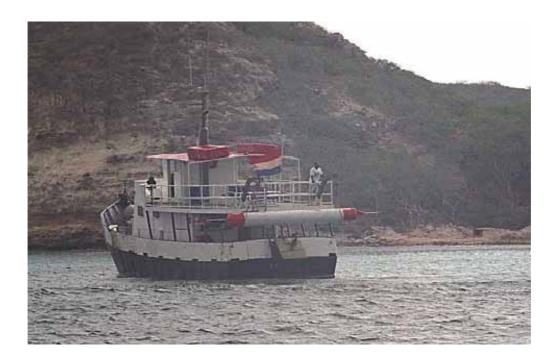
**RVS strengthened FAD, RVS 6** Smaller and lighter radar reflector, shortened lower mast with baffles

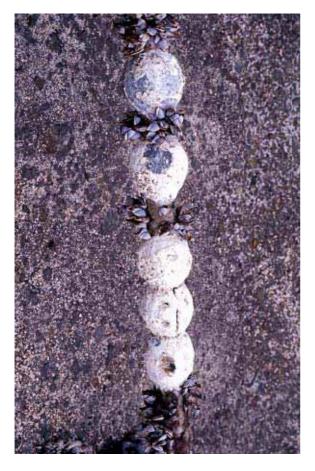
Anodes on the GRP MKII buoy, On the GRP buoy anodes will last for more than two years, even in areas with strong currents. On the stainless steel buoys anodes eat away much more rapidly and have to be replaced within a year. When the anodes are gone the shackles corrode very rapidly.

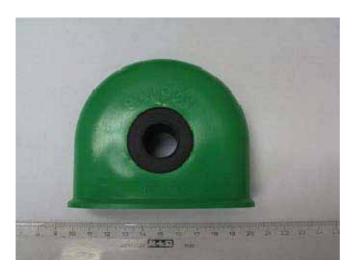
Samsom Ocean Company Nylite connector

- It is problematic to obtain Nylite connectors. The galvanised connectors used in some of the later buoys are probably not as dependable. A larger diameter galvanised connector has to be used and the rope passed through a plastic hose before passing it through the connector.

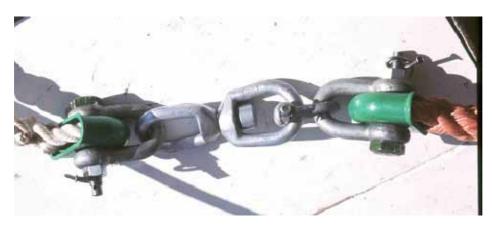
Intermediate swivel with Nylite connectors

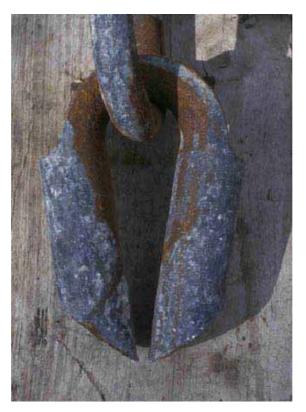
Galvanized connector, of inferior quality
