## Chapter 7

# Common problems in structures

## Chapter 8

# Maintenance and repair works

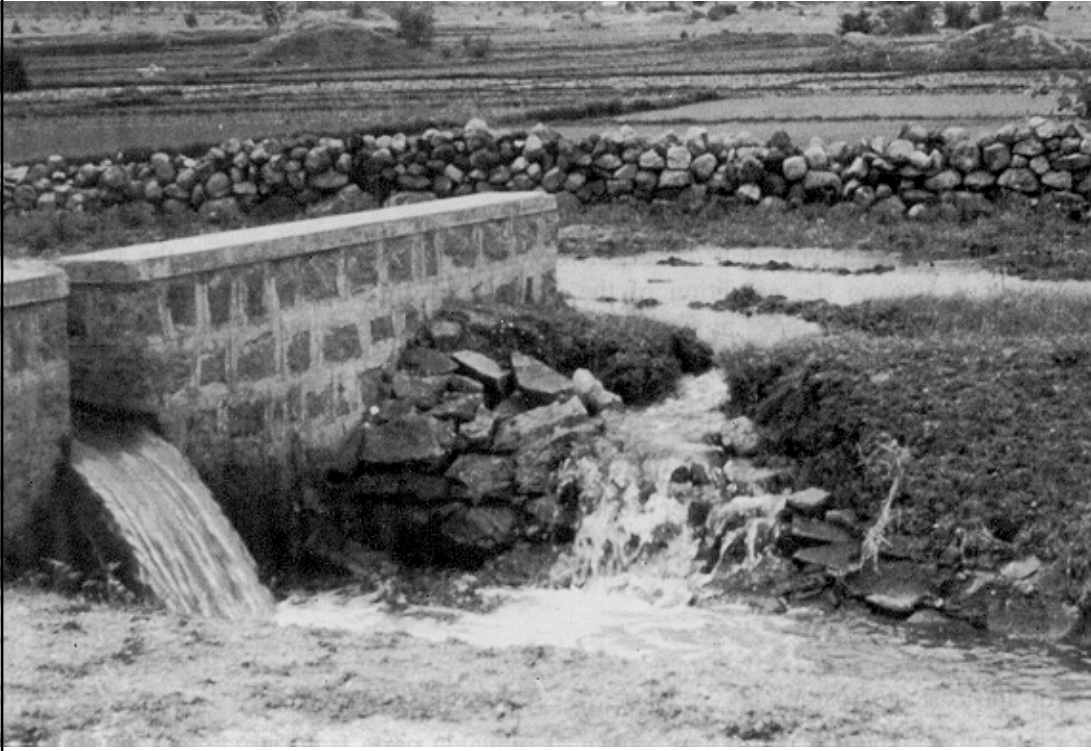
FIGURE 51  
Leakage around a structure

Such a situation is shown in Figure 51, where the upstream water level is so high that water can flow along the dam. If no action is taken to remedy this the structure can be undermined by erosion and will collapse.

The water level upstream of a structure is higher than the downstream water level. Therefore water may search for another way underneath or along the structure, or even through a crack in the bottom or sides of the structure to this lower level. The moment that water has found a small path there is a leakage problem, and at the same time the beginning of an erosion problem. Leaking water will enlarge the path by washing out the soil and so the leakage will increase. Finally the structure will collapse if the process is not stopped.

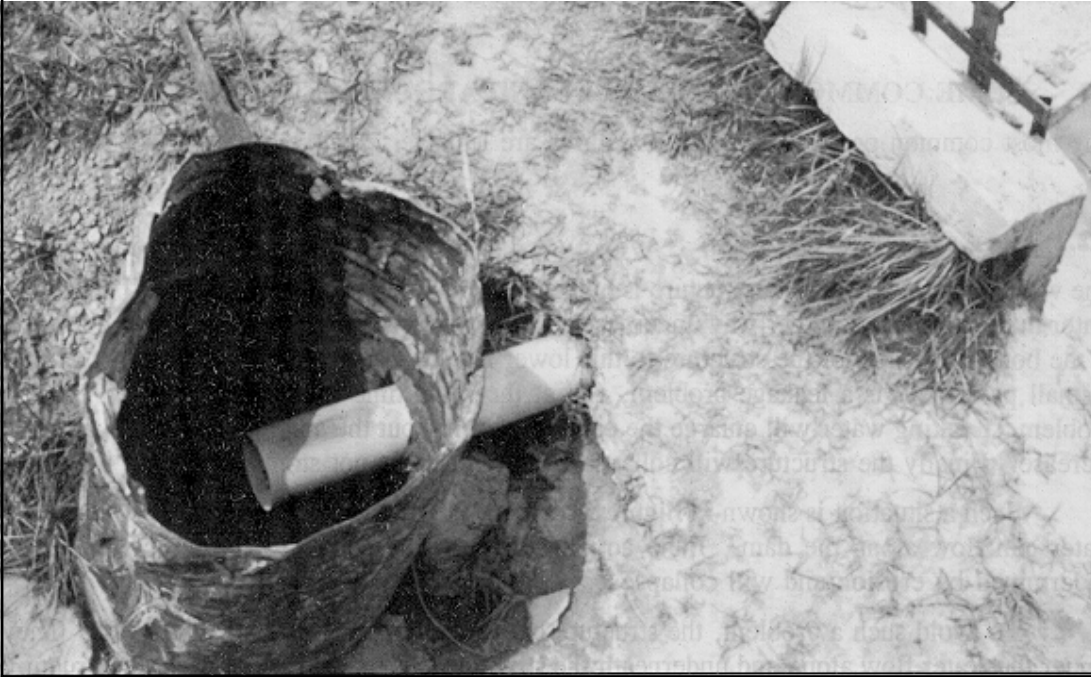
FIGURE 54  
Leakage that resulted in erosion

Figure 54 shows the result of a leakage that has been neglected for a long time. Most probably the connection between the canal lining and the pipe was not correctly made and water could leak between them and then flow along the pipe, and as a result has washed away the soil around the drum.

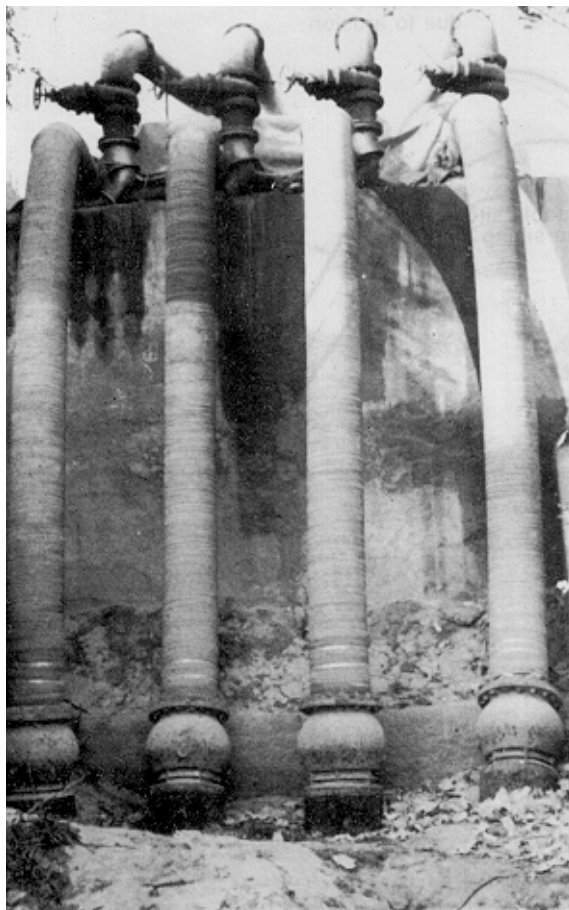
FIGURE 56  
A silted-up pumping station

The same applies for intake structures, such as the pumping station in Figure 56. Large volumes of sand in the intake chamber of the pumps causes damage to the pumps and will lead to sand deposits in the canal system too.
