ICID CONFERENCE SASKATOON, CANADA

Identified factors preventing farmers and scheme management from increasing their water use efficiency in Africa: Results of applied methodologies in Uganda

Eng. Mutumba Charles, Uganda

August 2018

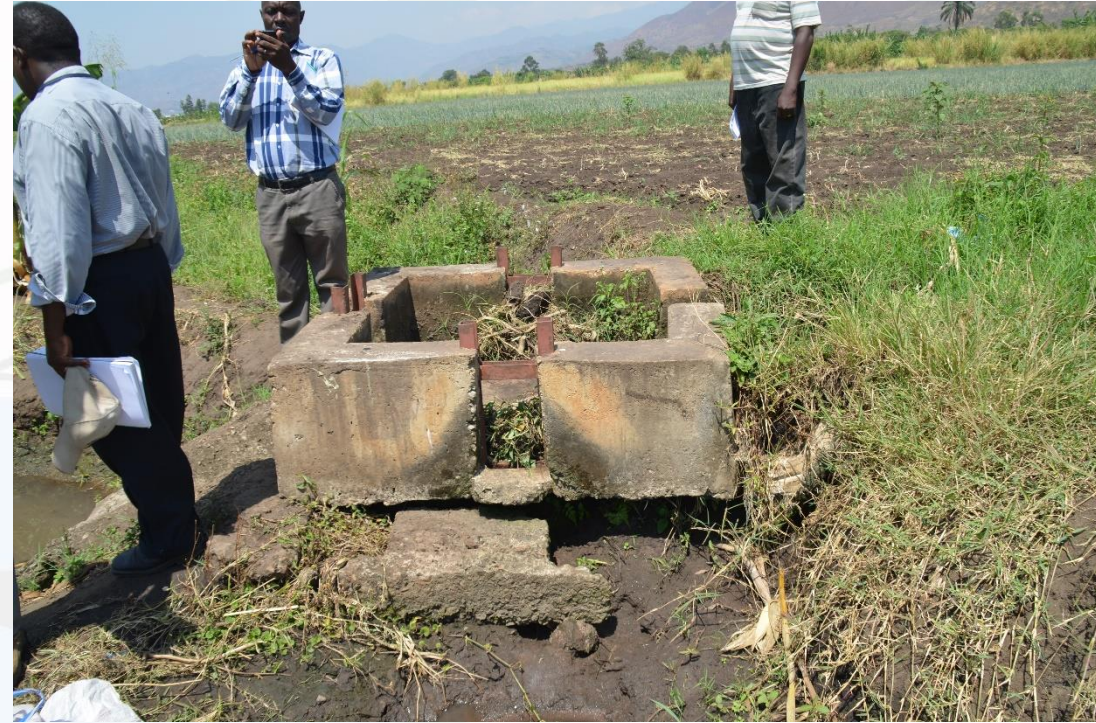
- Dilapidated infrastructure (seepage losses, leakages and limited control);
- Lack of specialized water measuring tools and equipment;
- Inadequate capacity for data capture and management;

Fig.3: Dilapidated tertiary canal & turnout

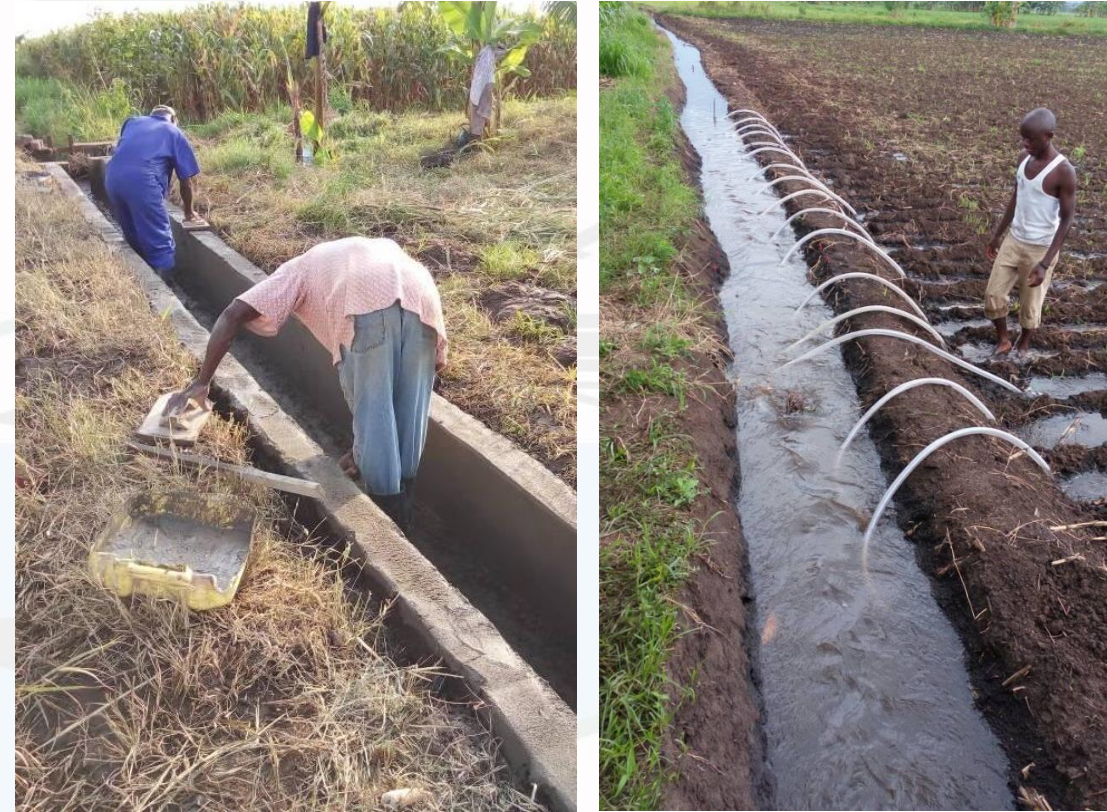
- 15 Tertiary canals lined to reduce seepage losses and to confine flow within the turnout for improved control;
- 15 Field canals reconstructed and bed levels raised to allow for easy flow manipulation and diversion to furrows;

Fig.5: Improved Tertiary and Field Canals.

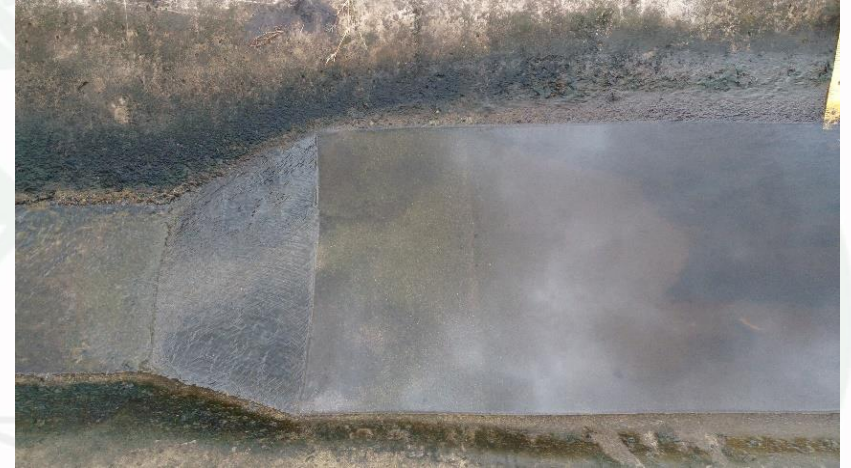
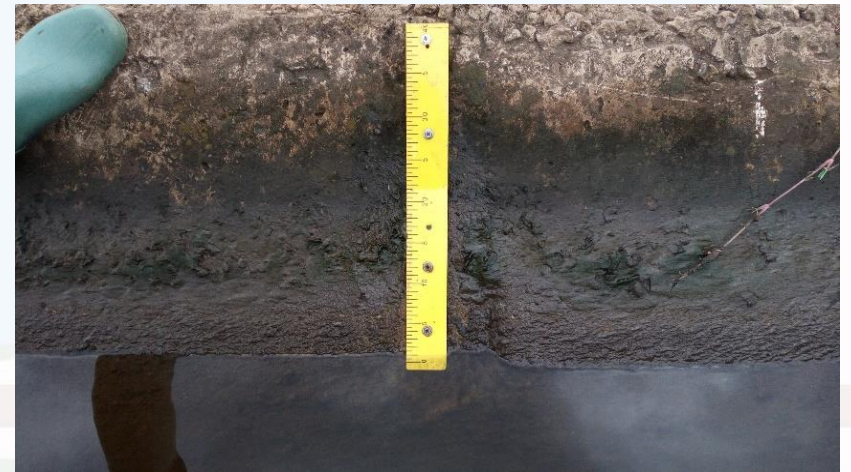
- Measurement structures installed at strategic points along selected secondary canals, calibrated and equipped with staff gauges for quick flow data capture;

Fig.6: Flow measurement in the Canals.

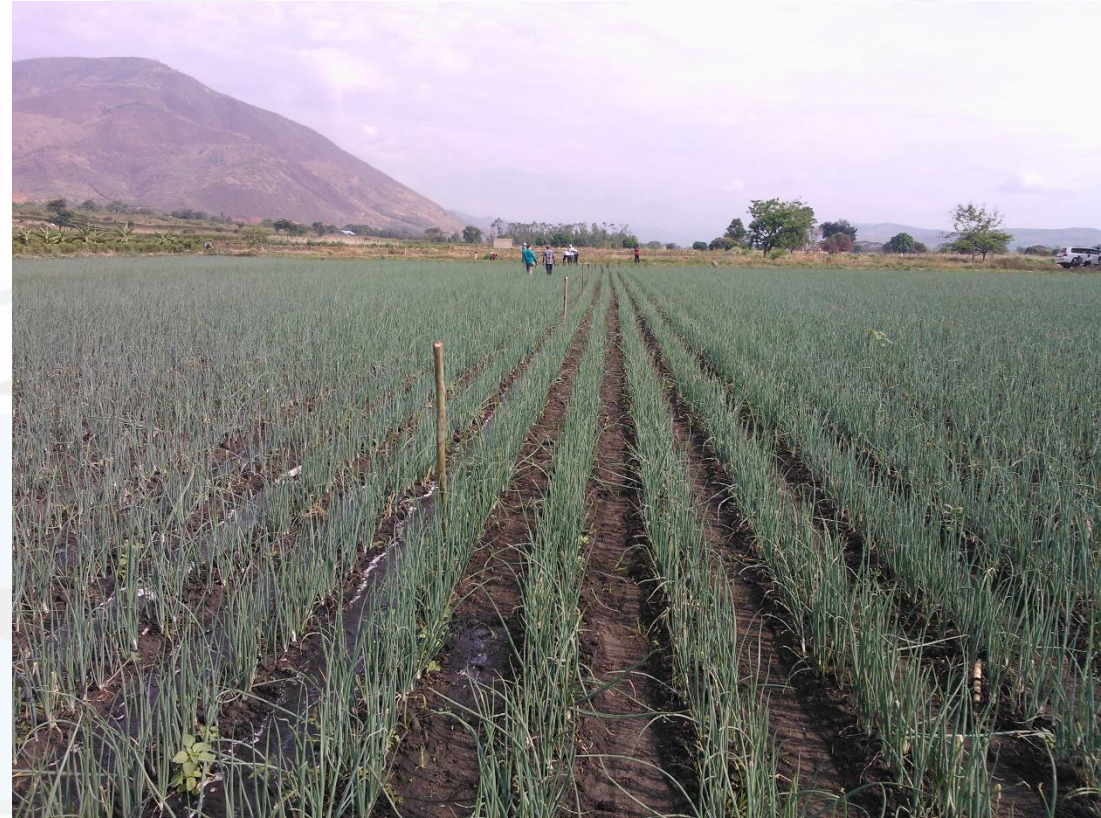
- Furrow discharge at optimal field parameters (efficiency, uniformity & adequacy) established for the different soil types;
- No. of furrows that can be irrigated simultaneously at a given field canal discharge determined;

Fig.7: Optimum water application assessment.

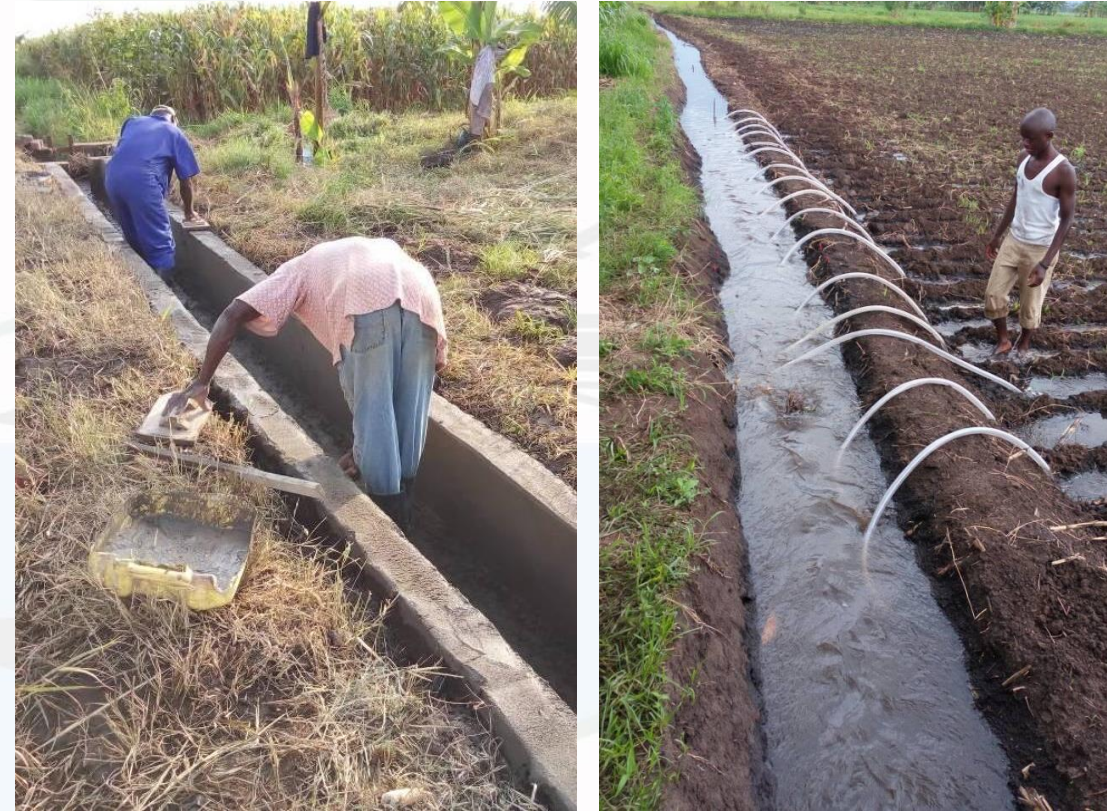
- Tertiary canals efficiency increased to 90%;
- Field canals bed levels raised to allow for easy flow manipulation and water application to as many furrows as can be permitted at the optimal service level;

Fig.8: Improved Tertiary and Field Canals.

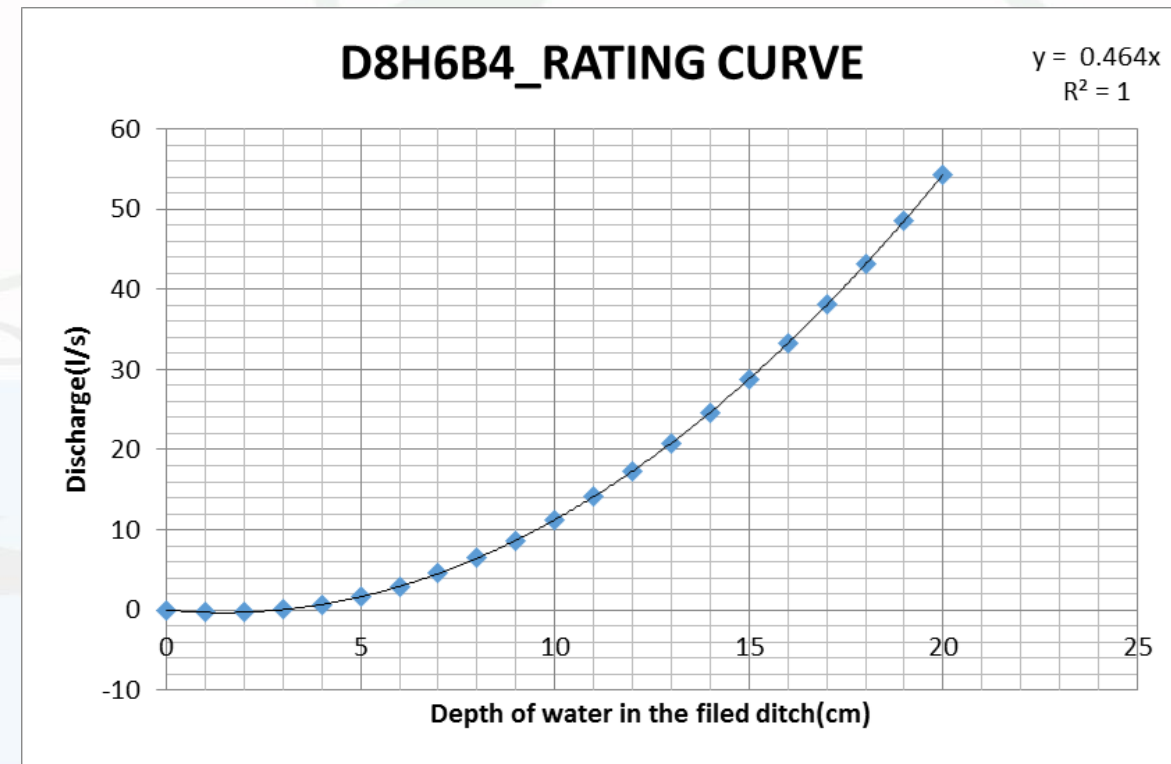
- Continuous flow data captured ;
- Rating curves generated to guide flow data collection;
- Rating curves from the Smart phone (iMoMo) data capture sites too were generated for comparison;

Fig.9: Rating generated for tertiary canal serving D8H6B4

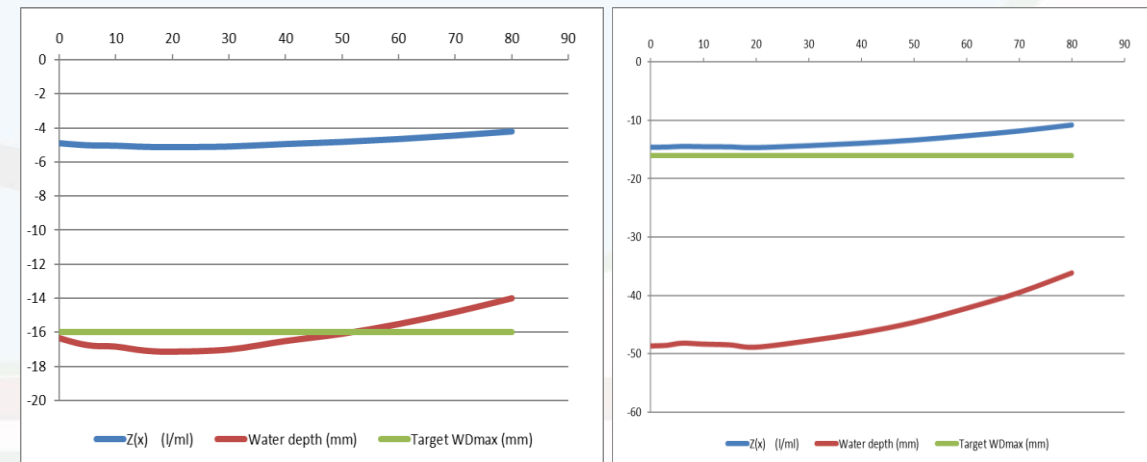
- Farms with loam soils registered high field application efficiency, distribution uniformity and adequacy at low furrow flows;
- Farms with sandy-clay-loam however registered high efficiency, uniformity and adequacy at high furrow flows;

Fig.10: Water management levels for loam & sandy-clay-loam

Experimental Plot	D1b-H7-4		D12	
Soil characteristics	Loam		Sandy-clay-loam	
Furrow discharge (l/s)	0.75	0.38	0.75	0.25
Uniformity	0.95	0.91	0.86	0.69
Efficiency	0.63	0.90	0.44	0.37
Deep Percolation Ratio (DPR)	0.34	0.01	0.82	0.59
Tail Water Ratio (TWR)	0.02	0.08	-0.26	0.04
Adequacy	1.54	1.02	2.85	2.57
